**Monitoring of masonry historical constructions:  
ten years of static monitoring of the world’s largest oval dome.**

This paper presents the analyses conducted on data acquired by the monitoring system of the “Regina Montis Regalis” Basilica of Vicoforte in the decade 2004-2014. The Basilica is a building of great historical, architectural and structural significance, owing its fame to its impressive masonry oval dome, the world’s largest of this shape (internal axes of 37.23 by 24.89 m).

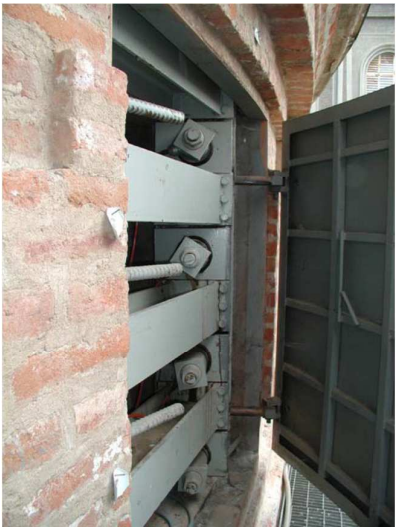
(a) Tie-bar ends equipped with load cells and (b) tie-bars end with the anchorage system.
